NATIONAL BUREAU OF STANDARDS REPORT

REPORT
OF
EXPERIMENTS TO DETERMINE THE FIRE RESISTANCES
OF
TWO PREFABRICATED WOOD WALLS

U. S. DEPARTMENT OF THE AIR FORCE
Headquarters U. S. Air Force
Washington 25, D. C.

Test No. 017148

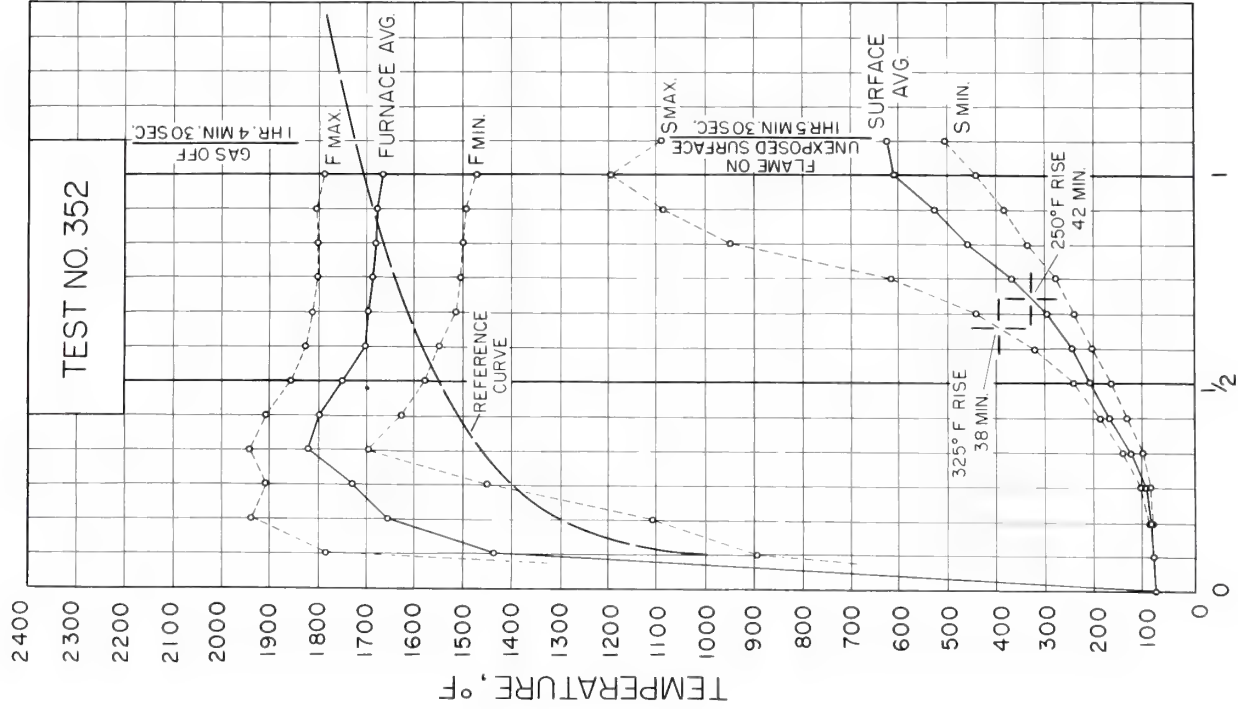
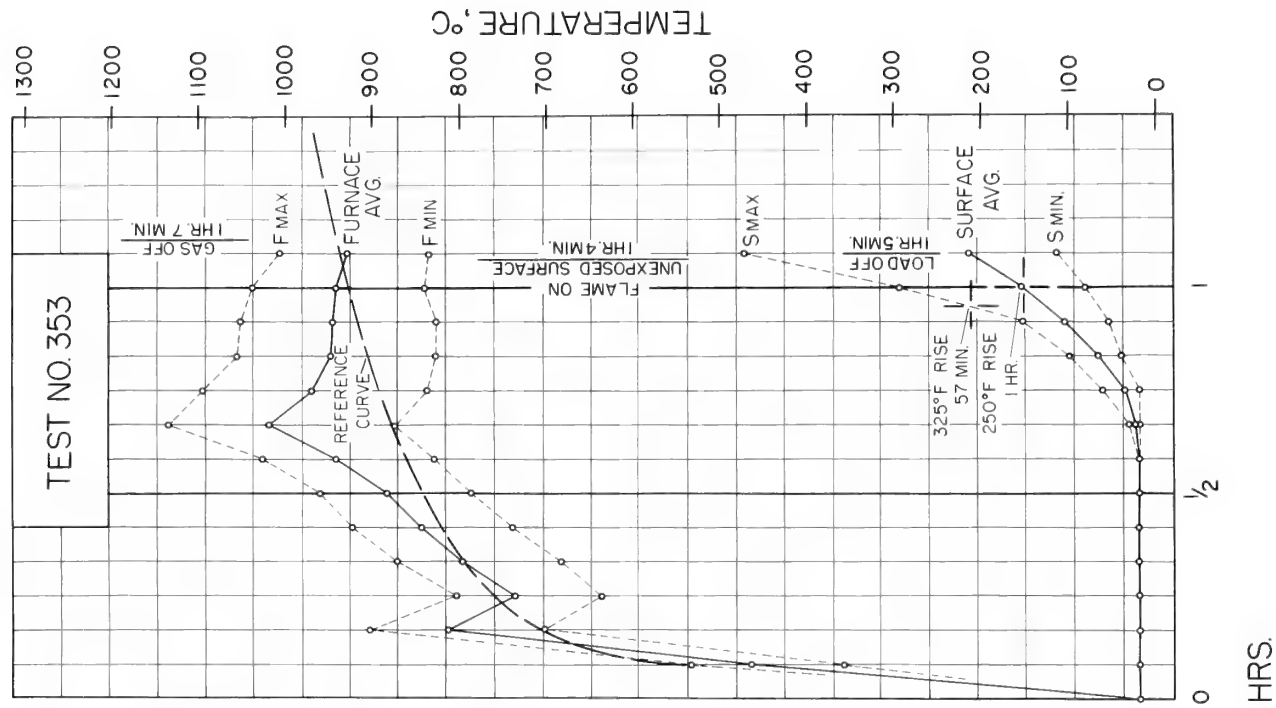
Figure 2. Temperatures observed during fire endurance tests.

The temperatures observed during the experimental test are represented in figure 2. The temperature at one thermocouple on the exposed surface had risen 30° degree F above the initial temperature at 30 min and the average of the unexposed surface had risen 450 degree F above the initial temperature at 42 min. The average furnace temperatures were higher than those of the standard time-temperature curve during most of the test. The fire exposure severity, defined as the ratio of the area under the curve of average furnace temperature to the area under the standard time-temperature curve, was 121 percent. Therefore, a correction of +6 min was applicable to the 36 min limiting time, making the expected fire endurance of the experimental specimen 42 min.

The temperatures observed during the experimental test are represented in figure 2. The temperature at one thermocouple on the exposed surface had risen 347 degrees F above the initial temperature at 57 min and the average at all the thermocouples on the exposed surface had risen 210 degrees F above the initial average at 1 hr. The average furnace temperatures were somewhat higher than those of the standard time-temperature curve during part of the test. The fire exposure severity was 103 percent. A correction of +1 min was applicable to the 57 min limit, making the corrected fire endurance of the experimental specimen 57 min.

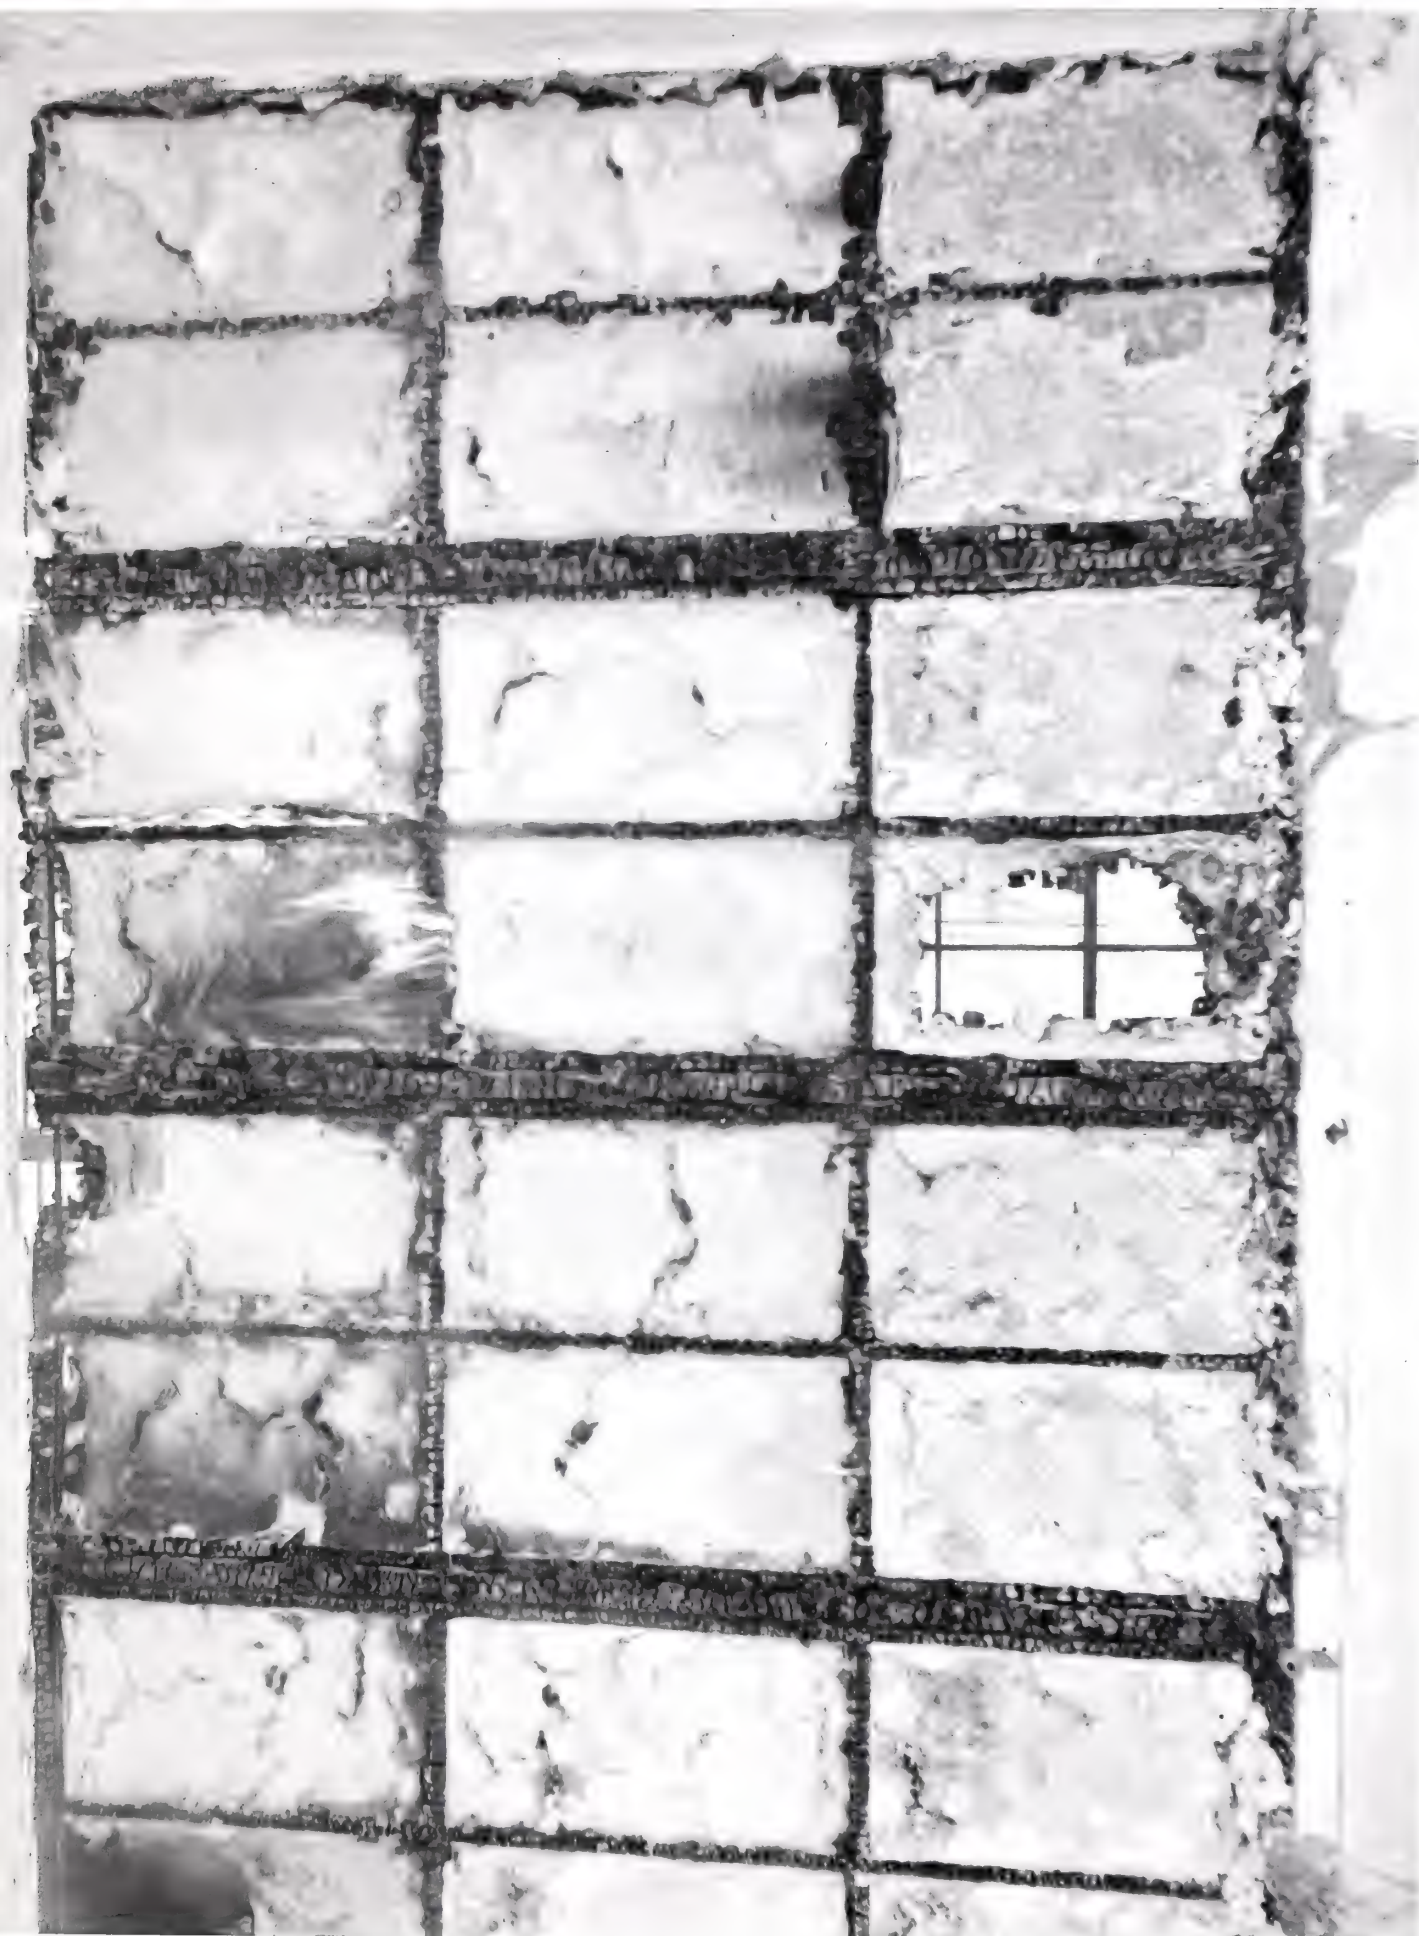
The specimen and frame were removed from before the furnace and all flaming extinguished by the water stream from a small hose. All the studs were badly charred. The glass fiber insulation was fused on the back of the exposed surface plywood.

Figure 3. Exposed surface of exterior wall after
fire endurance test 37a.

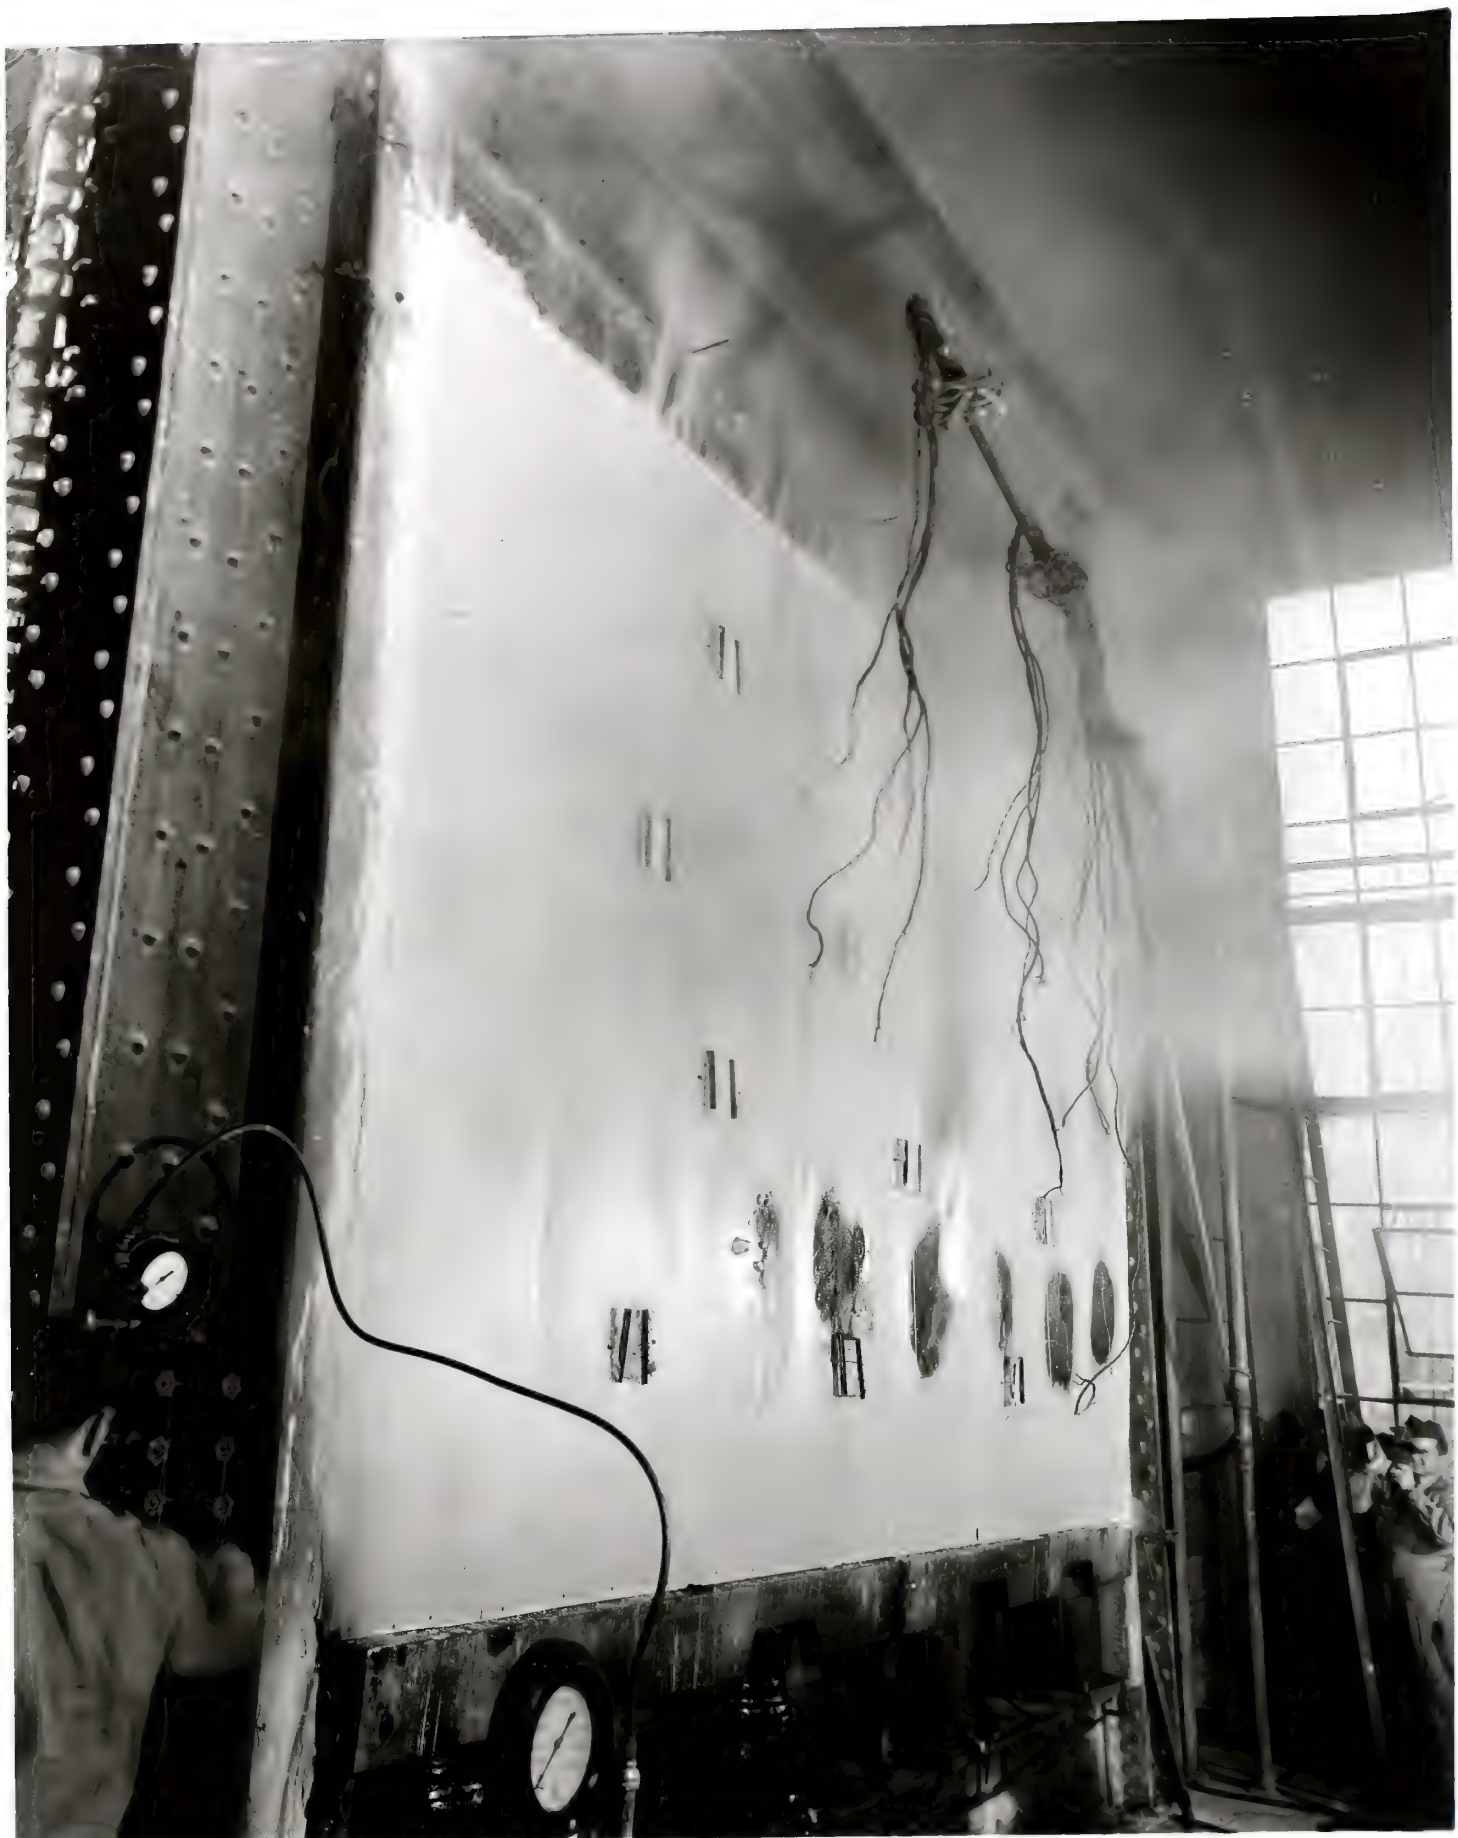
Figure 4. Damaged surface of fire-break wall
as flames started at 1 m of wall of
fire endurance test 333.

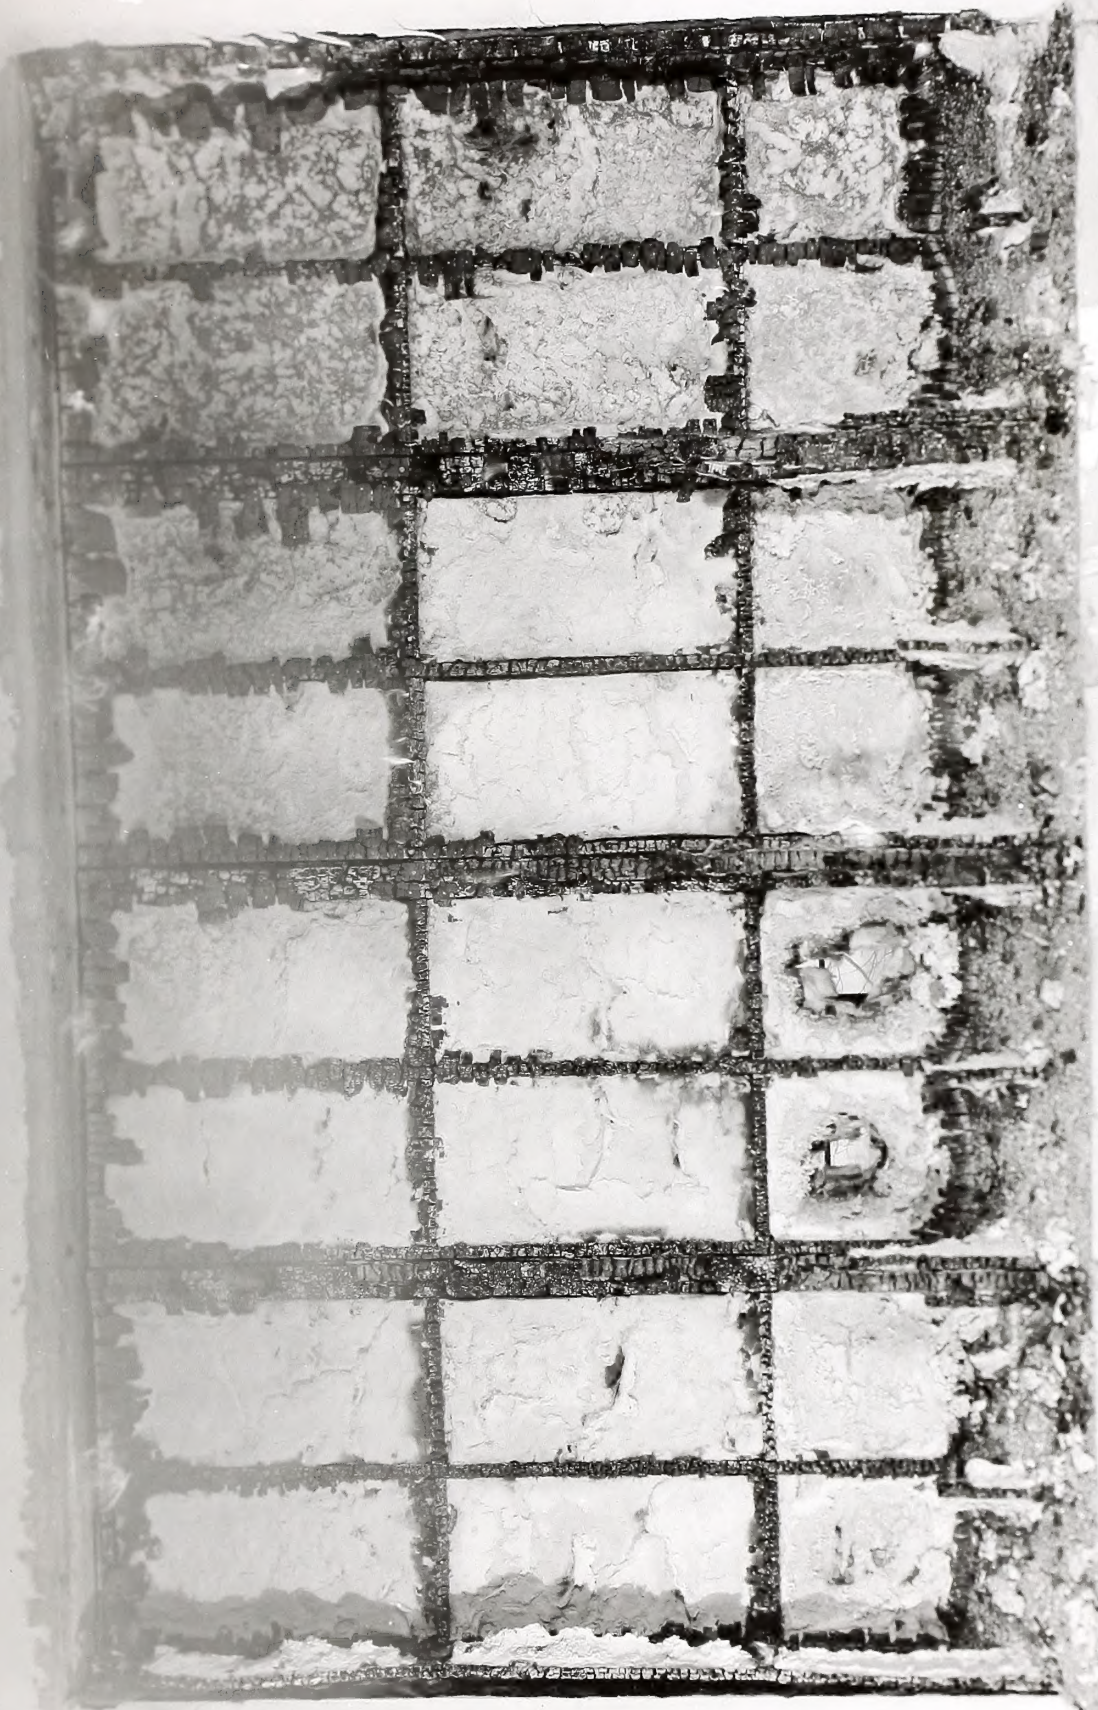
The specimen and frame were removed from before the furnace and a water stream played on from exposed side. The panels that had made up the exposed side of the wall were almost completely gone. The glass was burned from the inner faces of the panels that made up the exposed side of the wall and the glass fiber insulation was white and brittle. Over some areas, it had a granular texture in place of the original fibrous texture.

Figure 5. Section of fire-break wall from fire
side after test 151.
